The Road Inventory of Ouray National Wildlife Refuge Randlett, UT

Prepared By: Federal Highway Administration Central Federal Lands Highway Division April 2008

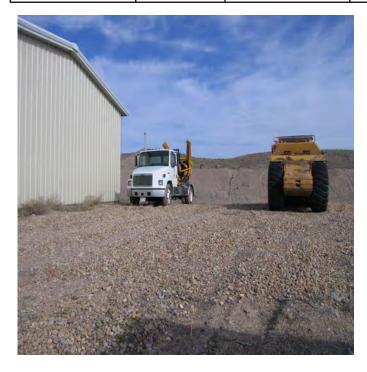
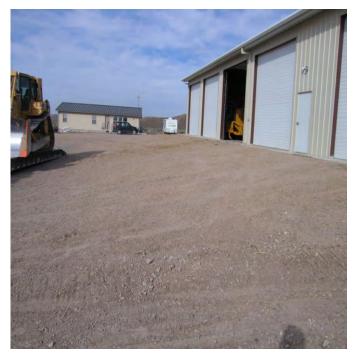
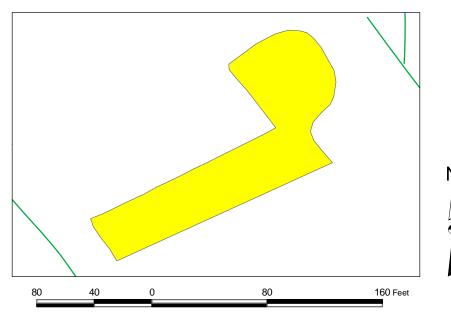
Asset Number	Date Visited	Surface Type	Area (sq ft)	Condition	Cost to Improve
10036044	4/28/2008	Gravel	6622	Fair	\$1600

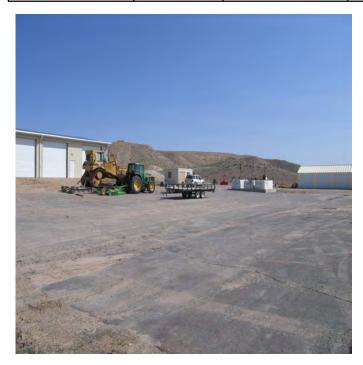
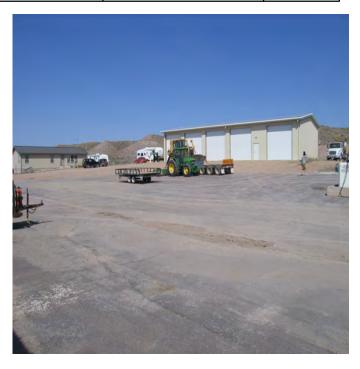
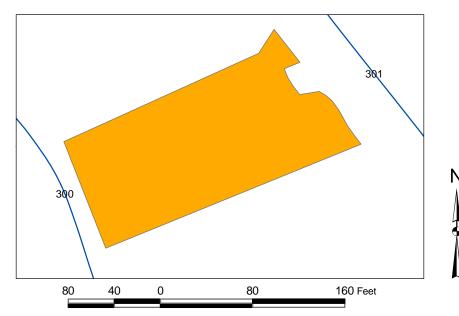
Ouray Route 801: Shop Asphalt Parking

Asset Number	Date Visited	Surface Type	Area (sq ft)	Condition	Cost to Improve
10034474	4/26/2008	Asphalt	17691	Poor	\$79700

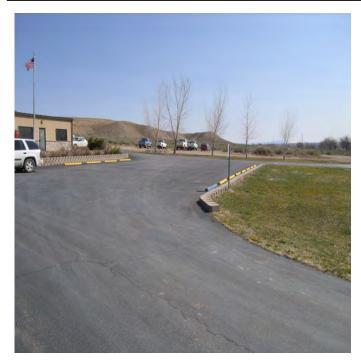
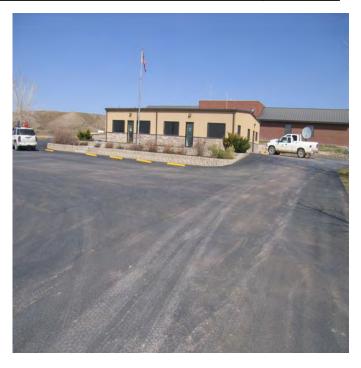
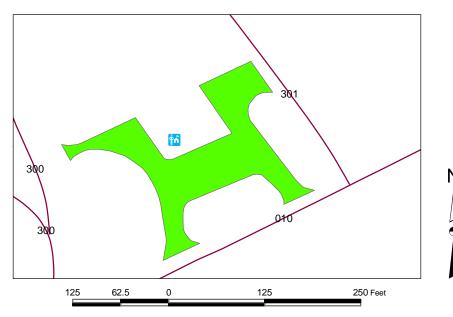
Ouray Route 900: Office Parking

Asset Number	Date Visited	Surface Type	Area (sq ft)	Condition	Cost to Improve
10034597	4/26/2008	Asphalt	15451	Good	\$2700

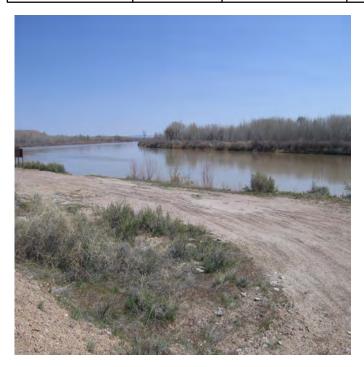
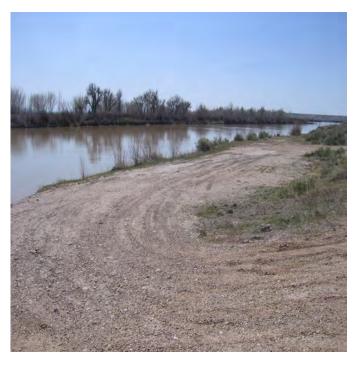
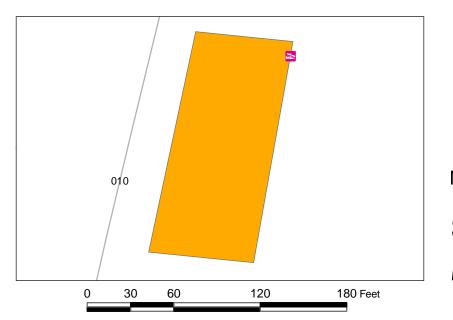
Ouray Route 901: Boat Ramp Parking

Asset Number	Date Visited	Surface Type	Area (sq ft)	Condition	Cost to Improve
	4/26/2008	Gravel	7870	Poor	\$8200

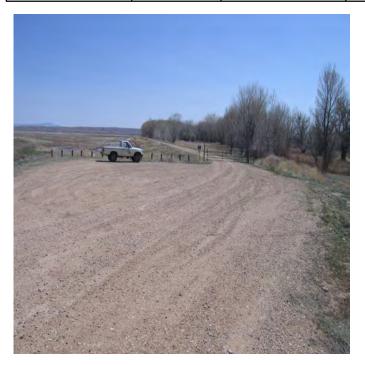
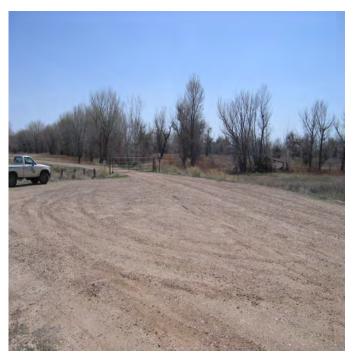
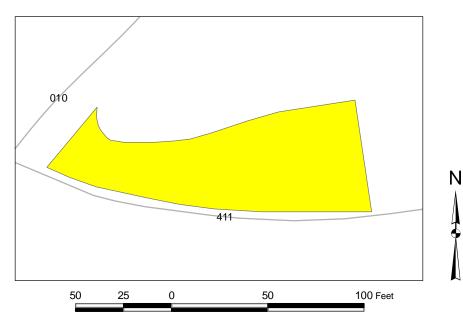
Ouray Route 902: Leota Bottoms Parking

Asset Number	Date Visited	Surface Type	Area (sq ft)	Condition	Cost to Improve
10036034	4/26/2008	Gravel	4931	Fair	\$1200

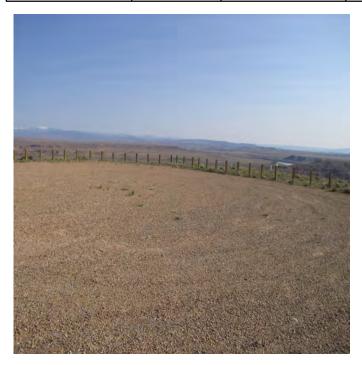
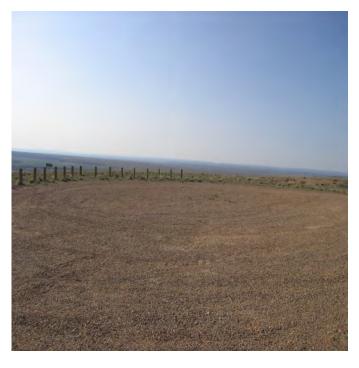
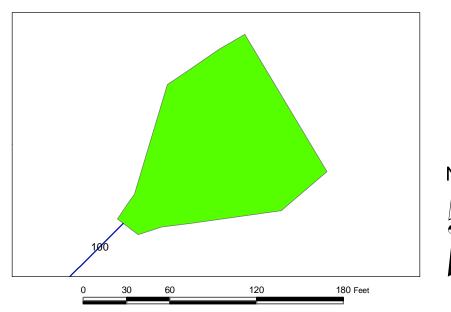
Ouray Route 903: Leota Bluff Parking

Asset Number	Date Visited	Surface Type	Area (sq ft)	Condition	Cost to Improve
	4/26/2008	Gravel	8531	Good	1200

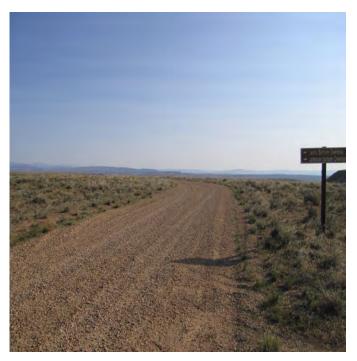
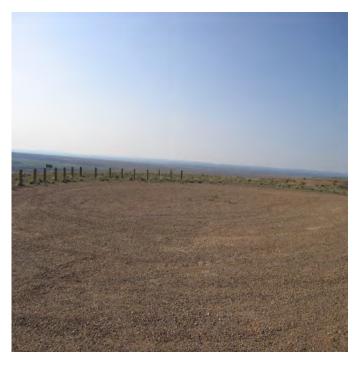
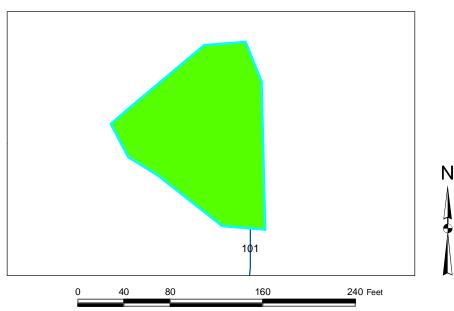
Ouray Route 904: Johnson Bluff Parking

Asset Number	Date Visited	Surface Type	Area (sq ft)	Condition	Cost to Improve
	4/26/2008	Gravel	50600	Good	10859

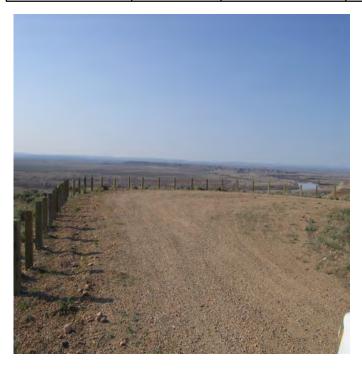
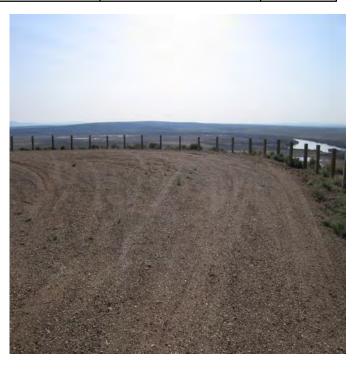
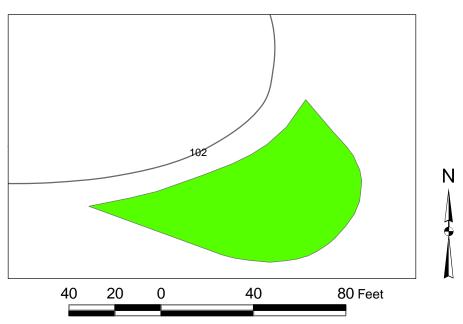
Ouray Route 905: Green River Geology Parking

A	sset Number	Date Visited	Surface Type	Area (sq ft)	Condition	Cost to Improve
		4/26/2008	Gravel	3023	Good	400

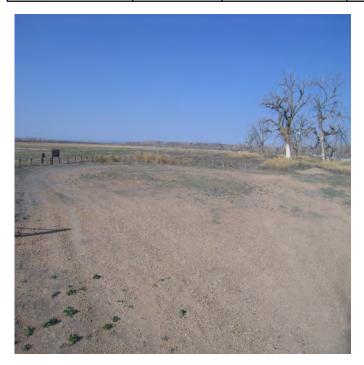
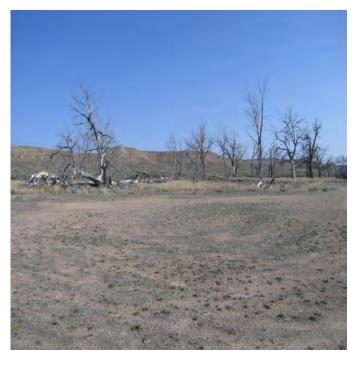
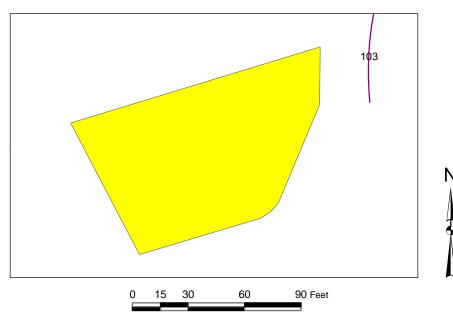
Ouray Route 906: Wildlife Viewing Area Parking

Asset Num	nber	Date Visited	Surface Type	Area (sq ft)	Condition	Cost to Improve
		4/262008	Gravel	31300	Fair	6731

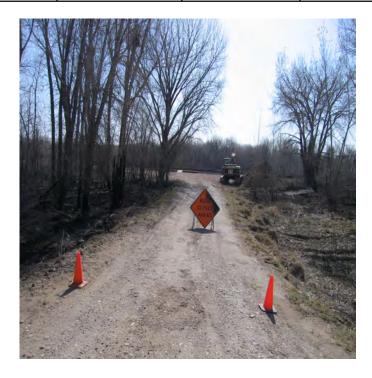
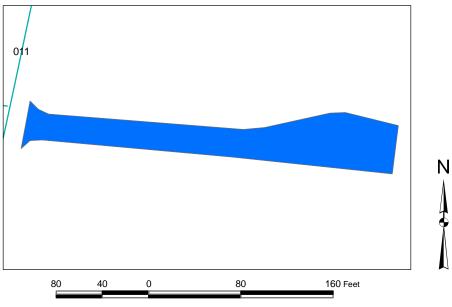
Ouray Route 907: Green River Parking

Asset Number	Date Visited	Surface Type	Area (sq ft)	Condition	Cost to Improve
	7/20/2004	Gravel	7567	Excellent	0

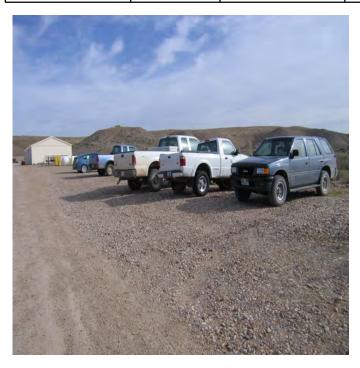
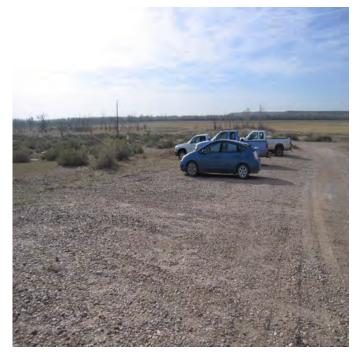
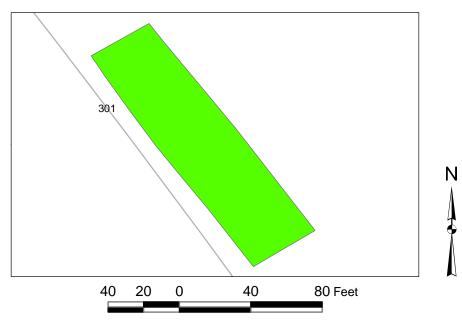
Asset Number	Date Visited	Surface Type	Area (sq ft)	Condition	Cost to Improve
10036044	4/28/2008	Gravel	4317	Good	\$600

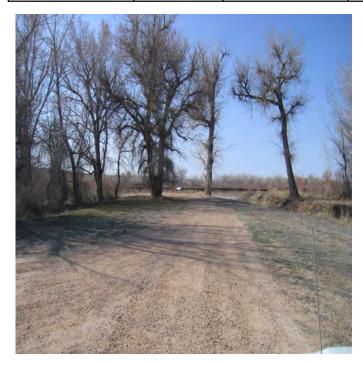
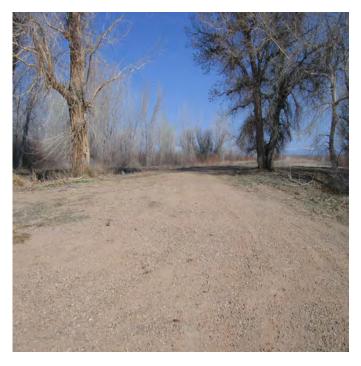
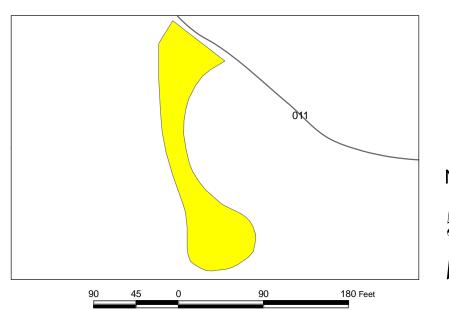
Ouray Route 909: Sheppard Drain Parking

Asset Number	Date Visited	Surface Type	Area (sq ft)	Condition	Cost to Improve
10036032	4/26/2008	Gravel	7956	Fair	\$2000
